LAKE COUNTY HEALTH DEPARTMENT

MEMORANDUM

RE: 0970500001-Lake County, Highland Park Municipal Landfill Inspection

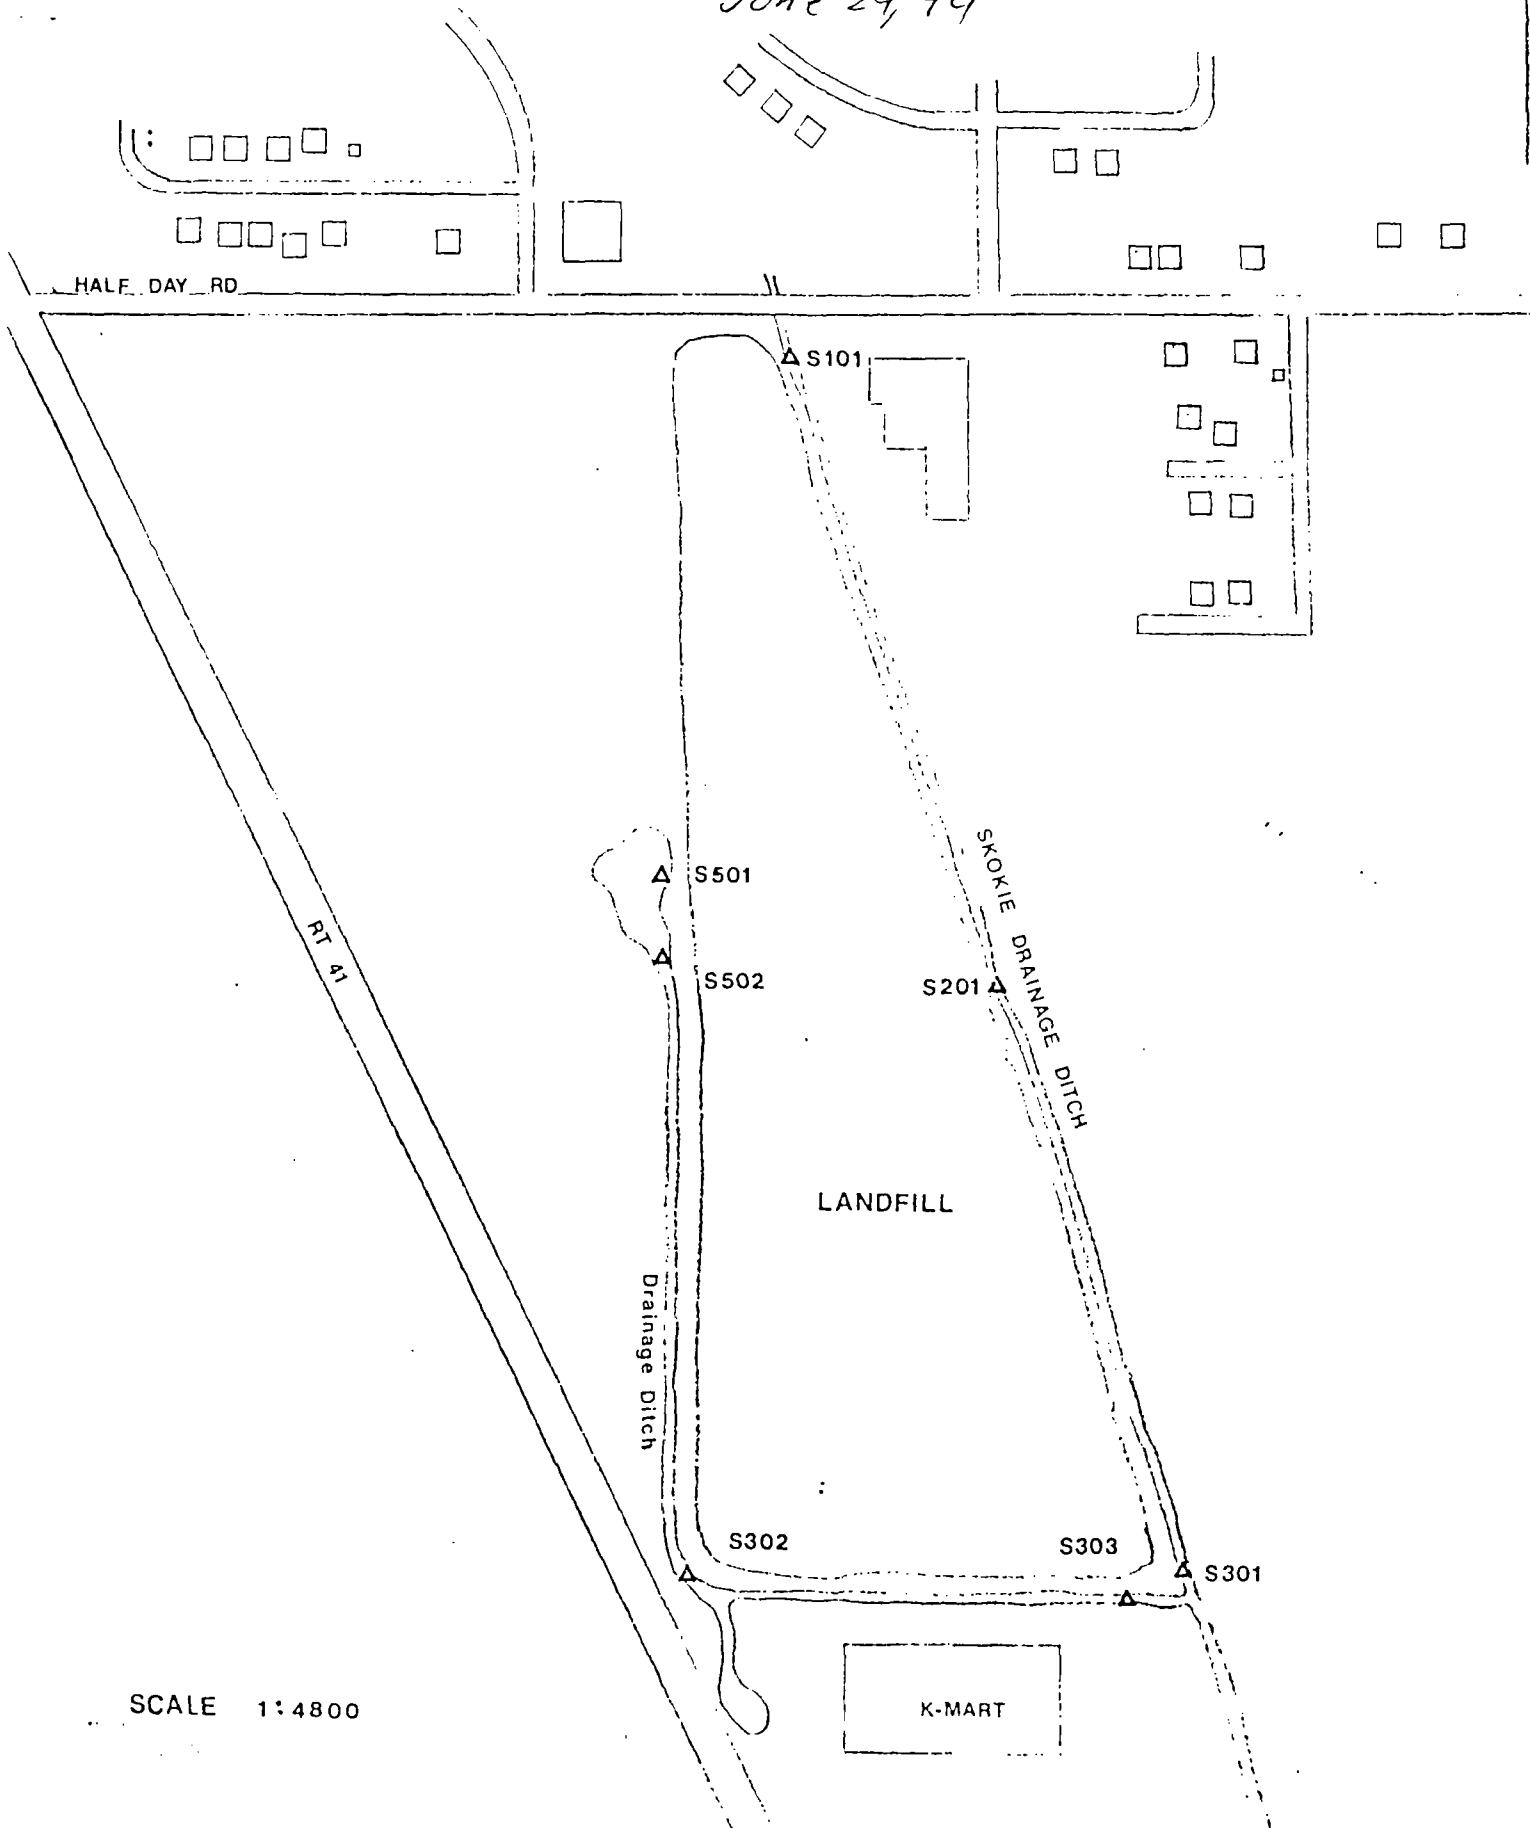
PHOTO # (s) 1

The south end of the landfill is being well maintained by the golf course with a dense vegetative cover (photo #1). Set back in one of the rough areas of the site has been accumulated significant amounts of yard wastes mixed with a small amount of refuse (photo #2). Previously this area was sighted for waste accumulation and a clean up was conducted by the Country Club. Because these wastes are predominantly organic, they appear to pose no impact on the landfill nor the surrounding environment. The area should be monitored to assure that the wastes accumulated are strictly yard wastes. The Country Club's manager will be contacted and informed of the waste accumulation and the need to remove any material from this area that does not meet the definition of yard wastes.

Overview of
southern section
of Highland
Park Landfill.

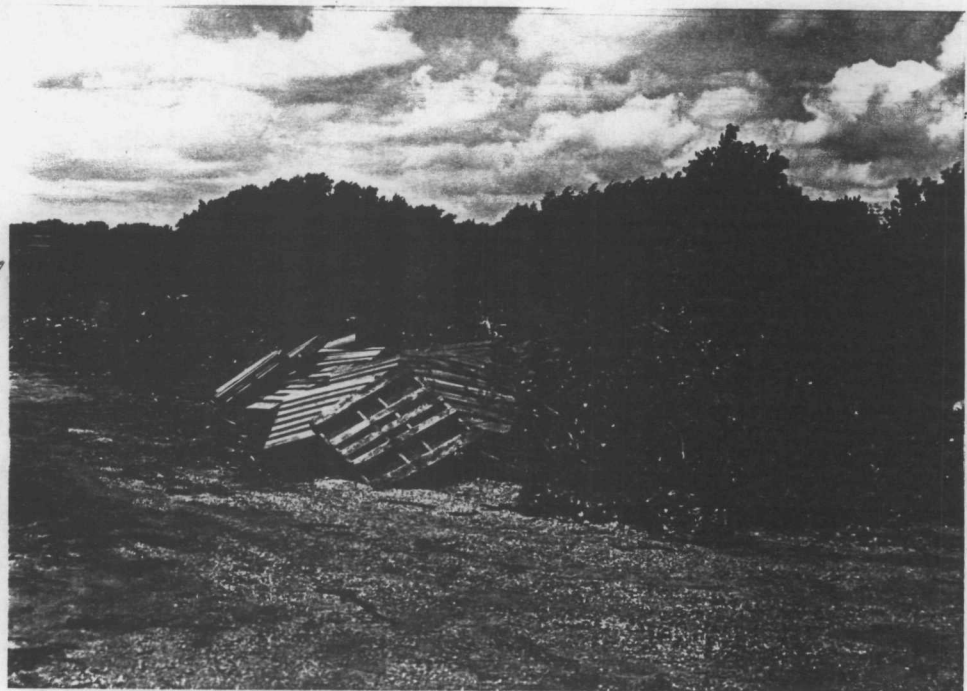
PHOTO # (s) 2

Yard wastes and
debris accumulated
along the southern
section of the
Highland Park
Landfill.

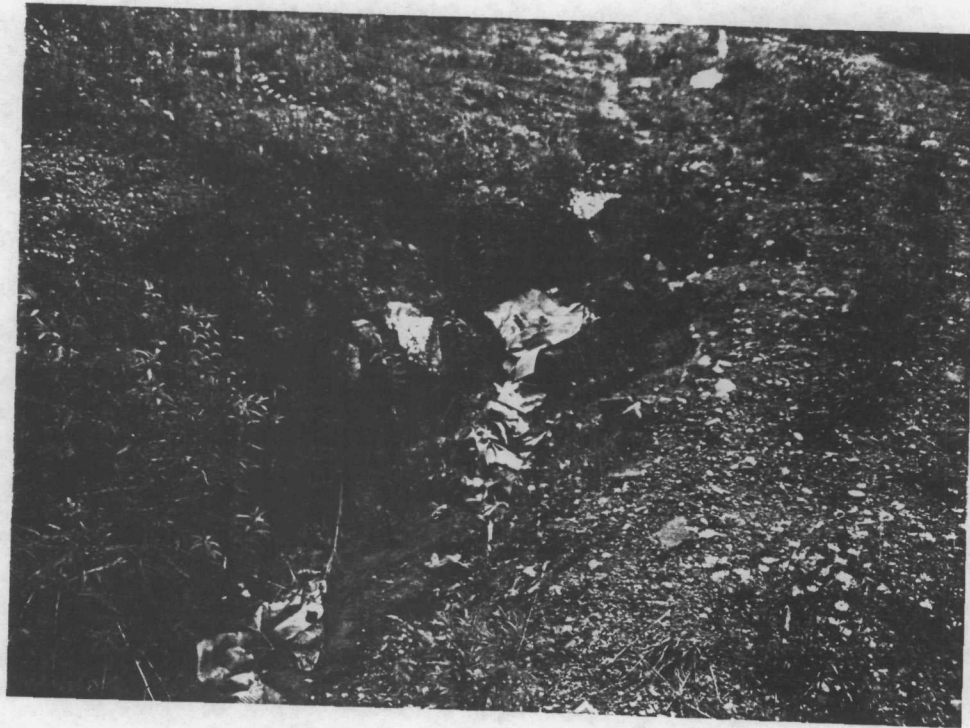
PHOTO # (s) 3

On the south end of the site the landfill is maintained in a clay cover and is used for material storage, as well as the training of fire fighters and a kennel for stray animals. An erosion problem exists due to the drainage pipe to move surface waters from the site's lower central section to the Skokie Drainage way along the east side of the site (photo #3 & 4). A significant erosion gully has been created at the end of the drainage way that jeopardizes the integrity of the site's cap. A letter addressing the control of this erosion problem will be sent to the City of Highland Park.

Point where drainage
pipe ends on the
north half of
the Highland
Pack landfill.
Pipe has led
to erosion at
the site.

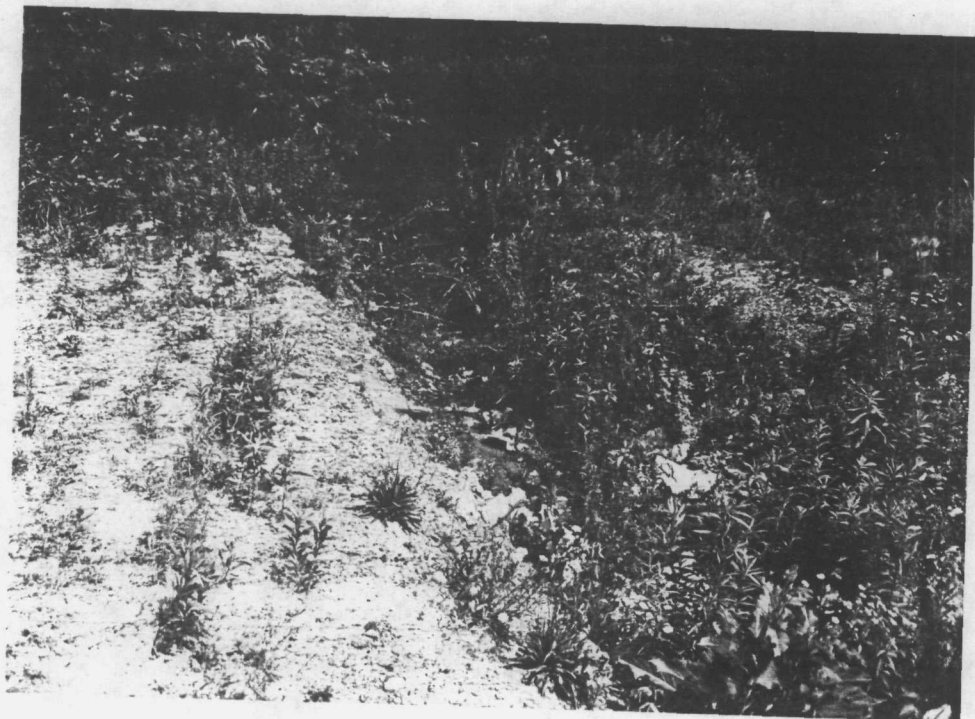
PHOTO # (s) 4

Erosion trench
created by
waters flowing
the site through
the installed
drainage pipe.
